Manhole Inspection Summary

Manhole # S31C__048MH

Insp Date: **5/26/09 3:54 PM**

Location Address: **MULBERRY ST**

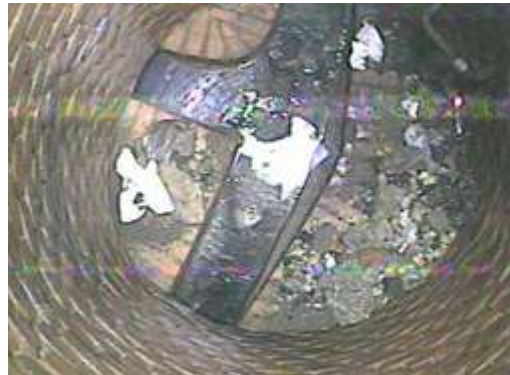
Top View

Offset: **1** (in.)

FRAME OFFSET

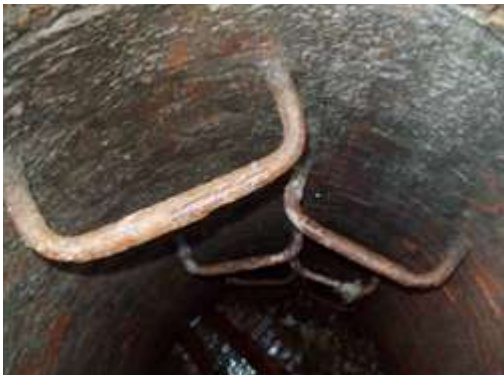
Defect 2

Count: **7** Missing: **0** ☒ **Corroded**

corroded steps

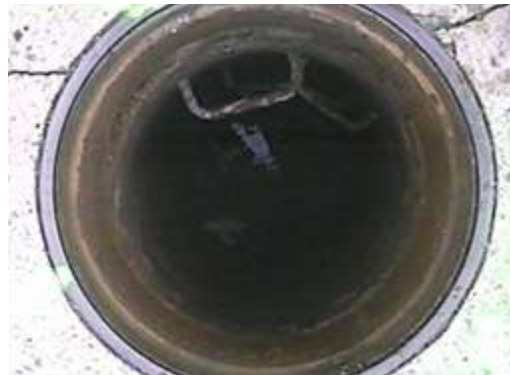
Defect 1

FRAME OFFSET

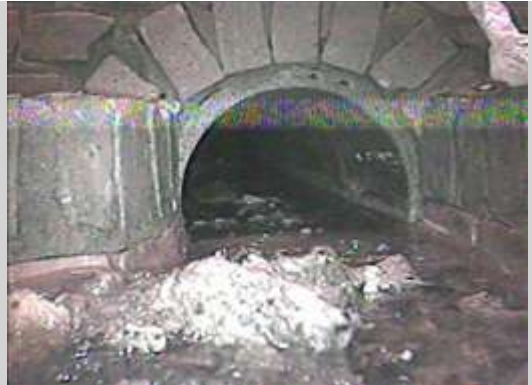
12 O'Clock Outflow

10 in. Circular Gravity Sewer
Pipe Out @ 12 O'Clock

Pipe Height: (in.) Direct
Pipe Material: **Clay** ☐ Pipe Lined
Invert Depth: **10.72** (ft.) Flow Characteristics: **Slow**
Deposits: ☐ None ☐ Mud ☒ **Sludge** ☒ **Debris** ☐ Grease
Silt Depth: **2** (in.) Deposits Extent: **Light**
Infiltration: **None** Pipe Seal Cond: **Sound**

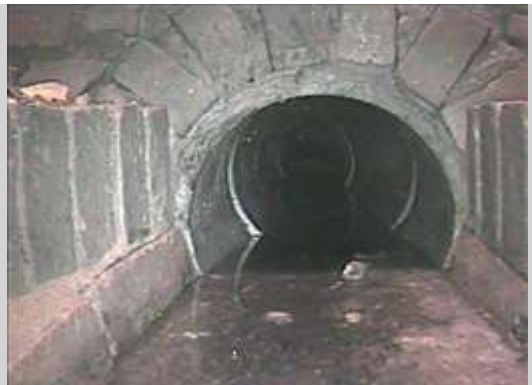
6 O'Clock Inflow

10 in. Circular Gravity Sewer
Pipe In @ 6 O'Clock

Pipe Height: (in.) Direct
Pipe Material: **Clay** ☐ Pipe Lined
Invert Depth: **10.76** (ft.) Flow Characteristics: **Slow**
Deposits: ☐ None ☐ Mud ☒ **Sludge** ☐ Debris ☐ Grease
Silt Depth: **2** (in.) Deposits Extent: **Light**
Infiltration: **None** Pipe Seal Cond: **Sound**

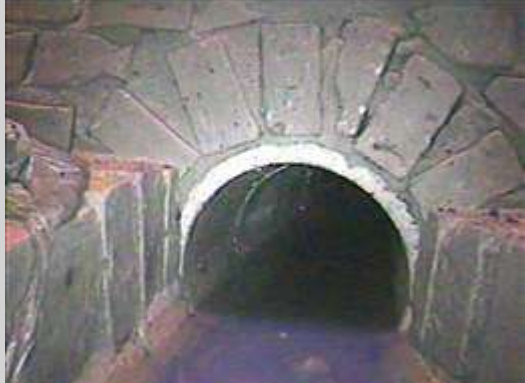
9 O'Clock Inflow

8 in. Circular Gravity Sewer

Pipe In @ 9 O'Clock

Deposits: ☐ None ☐ Mud ☒ **Sludge** ☐ Debris ☐ Grease

Silt Depth: **1** (in.) Deposits Extent: **Light**
